Transport Canada Transports Canada

TP 185E
Issue 3/2007

AVIATION SAFETY LETTER

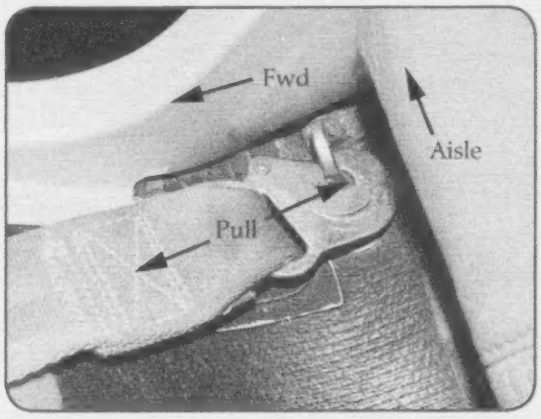
The two seat belts that failed had flipped around the U-shaped attachment fitting, and became lodged under a plastic trim molding on the side of the seat, adjacent to the aisle. A direct pull on the belt bent the spring keeper to the side, allowing the belts to become detached, even though the hook remained undamaged.

Figure 1: Seat belt hook snapped onto U-shaped fitting—pull is on hook

The seat belt is manufactured with a hole through the spring keeper to accommodate a cotter pin to lock the keeper in place. The locking provision was intended to prevent the unwanted removal of the seat belts. There is no *Technical Standard Order* (TSO) requirement by either the seat or seat belt manufacturer to have the cotter pin installed; the installation of the cotter pin is at the discretion of the operator. Misaligned seat belt clasps, without the cotter pin installed, take less of a pull to detach the seat belt from the seat attachment fitting. With the cotter pin installed, the misaligned belt has a better chance of aligning itself before a detachment occurs. These particular seat belts had the optional cotter pin installed.

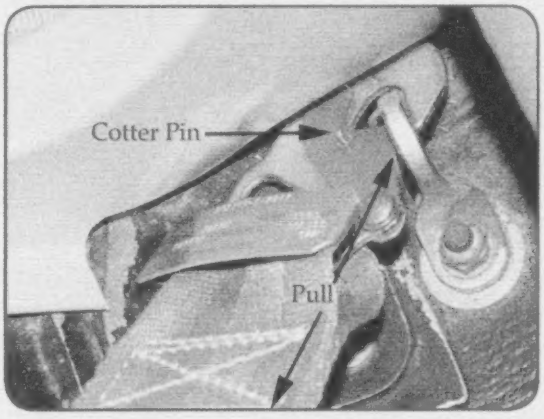
Figure 2: Hook flipped under trim molding —pull is on spring keeper

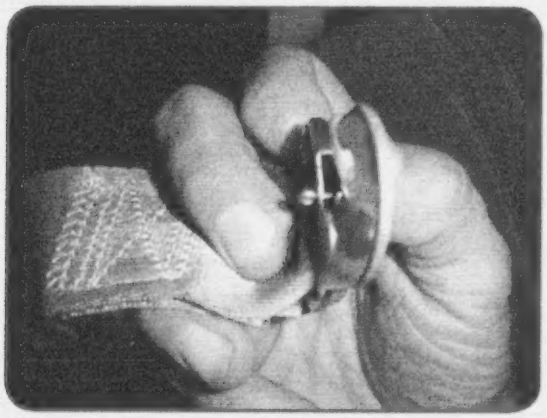
Figure 3: Bent spring keeper

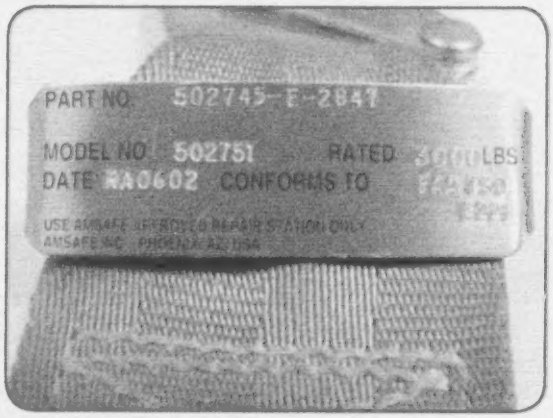
The two seats belts that failed were from the aisle seat locations. The seat belts, part number 502745-E-2847, model number 502751, are manufactured by AmSafe Inc. of Phoenix, Ariz. The seat belts are snapped onto the seat attachment point with a hook, which incorporates a spring keeper for quick installation and removal. The seat, ID number 8S0151-1/-2, is manufactured by PTC Aerospace (now owned by B/E Aerospace). The seat incorporates a U-shaped attachment fitting bolted to the seat structure to accommodate the seat belt.

Figure 4: Seat belt identification

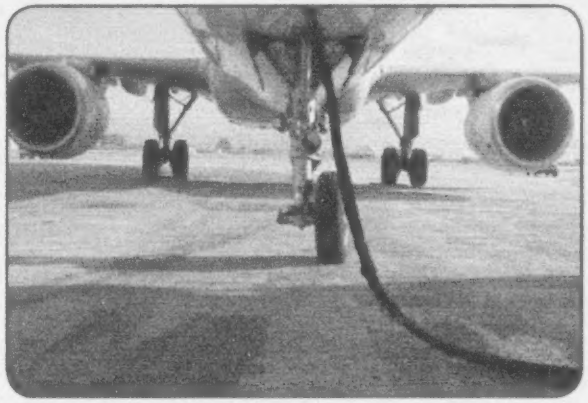
TSB Final Report A04O0016— Nose Wheel Axle Failure

On January 19, 2004, at approximately 14:10 Eastern Standard Time (EST), an Airbus A321-214 landed on Runway 06L at Lester B. Pearson International Airport, Toronto, Ont., after a flight from Montréal, Que. While taxiing to the terminal, the flight crew heard a noise from the nose landing gear area. As the aircraft turned onto the lead-in line at the gate, the ground marshallers observed that the right-hand nose wheel was missing, and immediately had the aircraft stopped. Maintenance personnel inspected the nose landing gear and determined that it was safe for the aircraft to proceed to the gate. Airport authorities closed Runway 06L to inspect for aircraft components and landing surface damage. The nose wheel was subsequently located on the ramp. There were no injuries and damage to the aircraft was limited to the nose landing gear assembly. The damaged components were removed from the aircraft and shipped to the TSB Engineering Branch for examination.

Aircraft at the gate, shortly after arrival

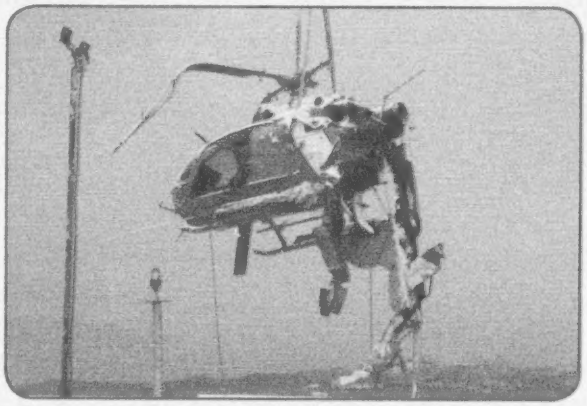
TSB Final Report A05A0155—Collision with Water

On December 7, 2005, a Messerschmitt-Boelkow-Blohm (MBB) BO-105 helicopter was being used for various tasks associated with the upkeep and operation of lighthouse and coastal navigation facilities in the Burin Peninsula area of Newfoundland and Labrador. While returning to Marystown, N.L., in the late afternoon of December 7, 2005, with one pilot and one passenger on board, the helicopter encountered heavy snow showers, and at about 16:28 Newfoundland Standard Time (NST), the helicopter crashed into the water of Mortier Bay, east of Marystown. Both the pilot and the passenger survived the water impact and escaped from the helicopter. However, the pilot perished from hypothermia, and the passenger drowned.

Aircraft during recovery, with cabin largely intact
